## RESEARCH ON ENHANCING SAFETY OF USING R290 REFRIGERANT IN FUTURE XEVS

Kunihiko HAYASHI \*, Yoshiaki MIYAZATO \*, Tomoki SHIMIZU \*\*

\* Toyota Motor Corporation, 1200 Mishuku, Susono, Shizuoka, 410-1193, Japan

### ABSTRACT

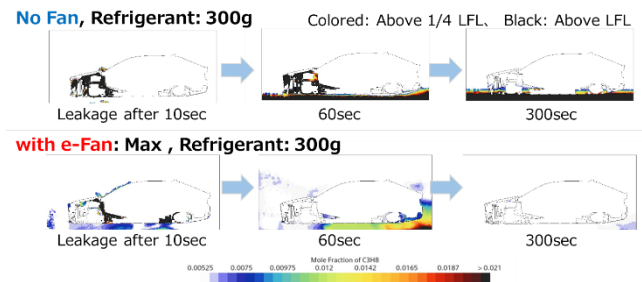
Fig. 5 CFD result (300g, with/without e-Fan)

The results for a 300g refrigerant leak are shown in Figure 5. Under conditions without fan operation, the gas released into the underhood area gradually settled near the floor. By 300 seconds, gas concentrations exceeding the LFL were observed near the floor. In contrast, when the e-Fan was activated immediately after the leak, airflow promoted the diffusion of stagnant gas, significantly reducing the high-concentration zone. After 300 seconds, the entire area was below the LFL.

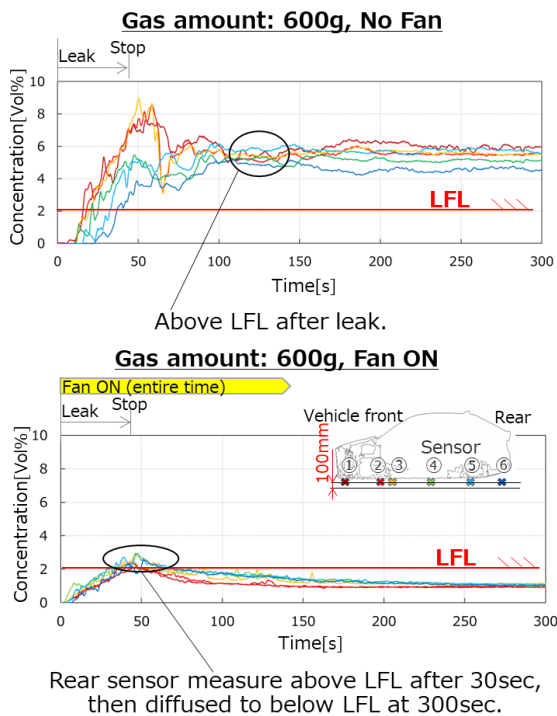
Fig. 9 Gas leakage in the garage (with/without e-Fan)

Figure 9 shows the results of an actual vehicle evaluation involving a fast leak of 600g of refrigerant, the most severe test condition. Without airflow, the gas concentration measured by the sensor placed 100mm above the floor exceeded the LFL 15 seconds after the leak began and remained above the threshold even after 300 seconds, indicating the accumulation of combustible gas. In contrast, when the e-Fan was operating, the concentration briefly exceeded the LFL at 30 seconds but was significantly reduced due to enhanced diffusion. By 300 seconds, the concentration had fallen below the LFL throughout the test area.

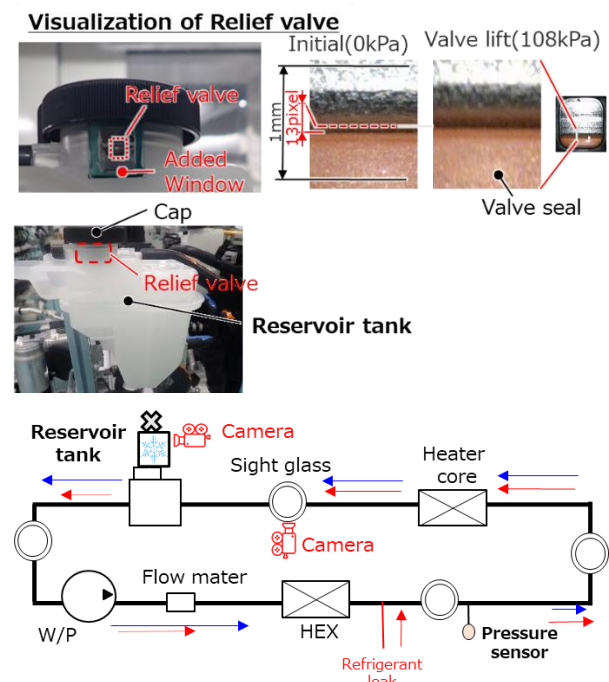
Fig. 16 Verified cooling loop and visualization point

The cooling loop, configured as a heating loop for a BEV, is shown in Figure 16. It includes a water-cooled condenser, an electric water pump, a heater core, a reserve tank with a relief valve, and a visualization sight glass. To monitor valve operation, a visualization window was machined into the relief valve, allowing direct observation of its status during the test.

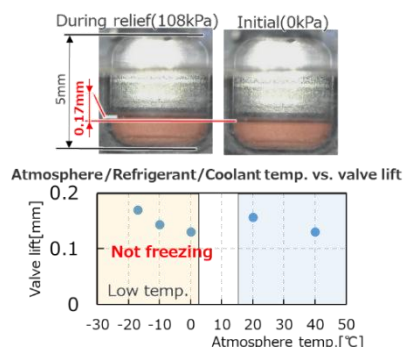
Fig.18 Temperature vs. relief valve lift

Figure 18 summarizes the initial temperature and valve operating state based on the relief valve visualization results. The valve functioned normally even at low temperatures, and anticipated sticking due to freezing did not occur.

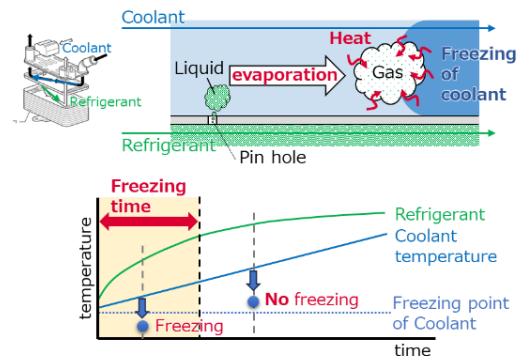
Fig. 19 Freezing mechanism in the cooling loop

Next, we evaluated the potential for liquid refrigerant intrusion under worst-case conditions. As shown in Figure 19, if low-temperature liquid refrigerant enters the cooling loop, there is a concern that the coolant may freeze due to the latent heat of refrigerant vaporization, which occurs following a pressure drop after intrusion. To assess this risk under particularly severe conditions, we examined the possibility of freezing during a steady-state condition.

Additionally, since liquid refrigerant leakage from the heat exchanger is assumed to be transient during warm-up, we investigated whether freezing could occur during this phase using temperature and visualization techniques.

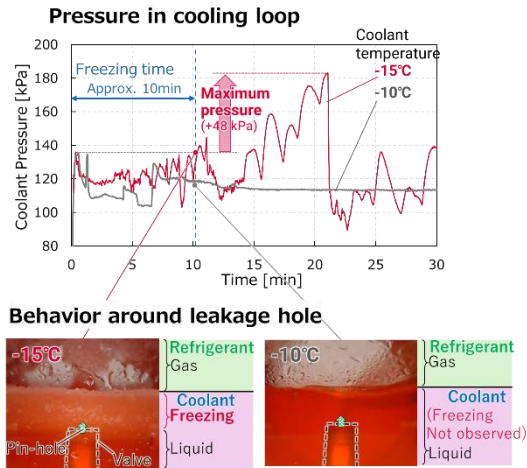
Fig. 21 Liquid leakage into the cooling loop (steady state)

As shown in Figure 21, under steady-state conditions with a coolant temperature of  $-15^{\circ}\text{C}$ , it took about 10 minutes from the intrusion of liquid refrigerant to the start of freezing, after which a pressure increase was observed. For comparison, since freezing was not observed at a coolant temperature of  $-10^{\circ}\text{C}$ , we checked whether a temperature rise of  $\Delta T = +5^{\circ}\text{C}$  within 10 minutes occurred under warm-up transient conditions.

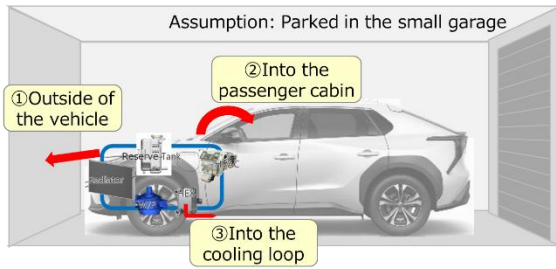
Fig.2 Possible Gas leak route

フロントコンパートメントに冷凍サイクルを搭載する車両は、冷媒ガスの漏洩ルートとして、図 2 のように、①外部への直接漏洩、②客室へのガス侵入、③冷却回路を通じた外部又は客室への漏洩が想定される。SAE ではリスクアセス検討結果、厳しい条件として、小型ガレージ内時の漏洩を指摘しており、本検討はこの条件で検証を行った。

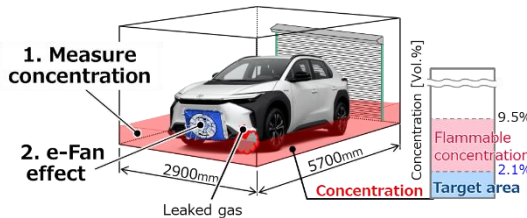
Fig.3 Environmental condition

CFD と実車を用い、図 3 に示す小型ガレージ内での車両外部ガス漏洩を検証する。また漏洩時リスク削減策として、車載ラジエータファン作動による強制対流を用いた濃度低減効果も検証する。車両は BEV の Toyota bZ4X とし、ガレージ後方にガレージシャッターを想定した 3mm 幅スリットを縦方向に設定し、外部との換気を再現している。

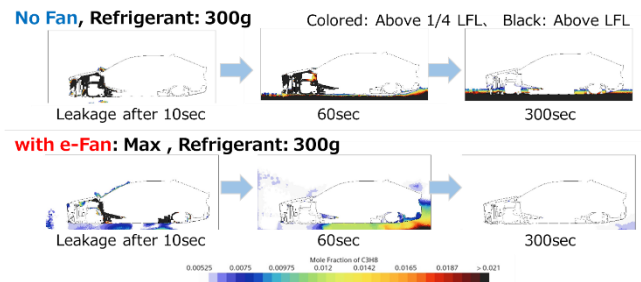
Fig.5 CFD result (300g, with/without e-Fan)

冷媒漏洩量 300g の結果を図 5 に示す。無風条件では、漏洩直後フロントコンパートメント内に放出したガスが次第に床付近に沈降し、300 秒時点で床付近に LFL を越える濃度のガスが存在する。一方、漏洩直後に車載ファン稼働する条件では、風流で滞留ガス拡散が促進され高濃度範囲が大幅に減少、300 秒後に全域で LFL を下回った。

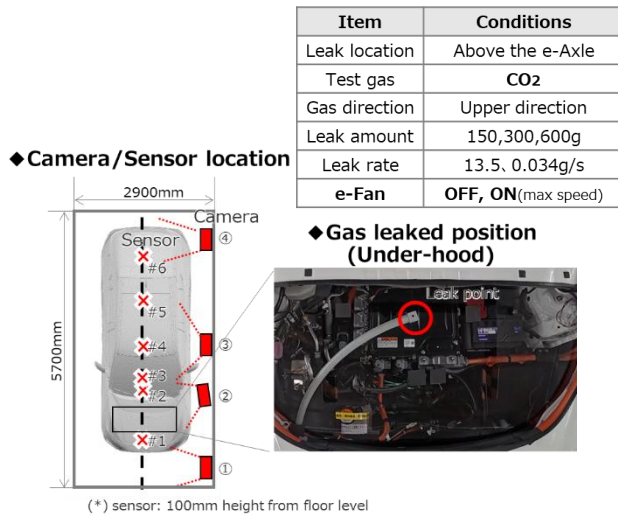
Fig.7 Actual vehicle test condition

図7に示すように、フロントコンパートメント内、e-Axle 上方にガスを放出する条件で実証試験を行った。ガス漏洩量、速度、車載ファン作動条件についても CFD と同条件で評価を行っている。

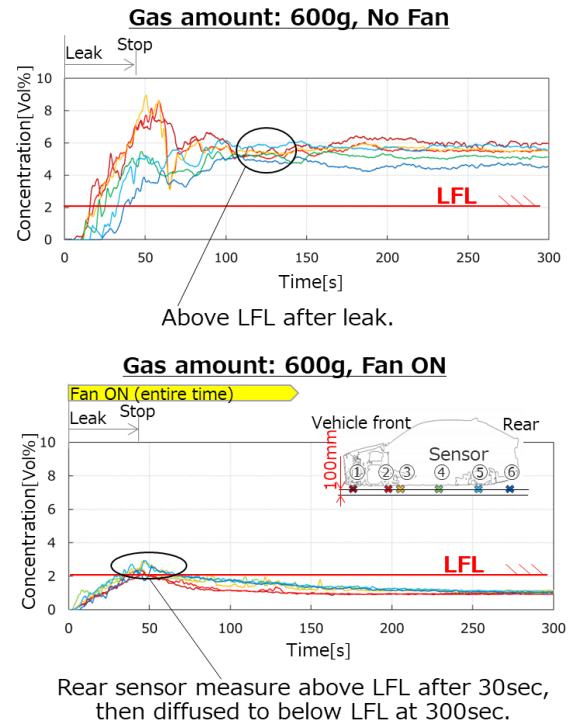
Fig.9 Gas leakage in the garage (with/without e-Fan)

実車評価結果として、最も厳しい条件となる、速い速度で 600g 漏洩した結果を図9に示す。無風条件では、床から高さ 100mm に設置したセンサー濃度が、漏洩 15 秒以降で LFL を越え、300 秒経過後も高い状態を維持し、可燃ガスが滞留することが分かる。一方で、漏洩直後から車載ファンを稼働させると、30 秒以降で一時的に LFL を越えるものの、拡散が促進され濃度が減少、300 秒時点では LFL を下回る結果となった。

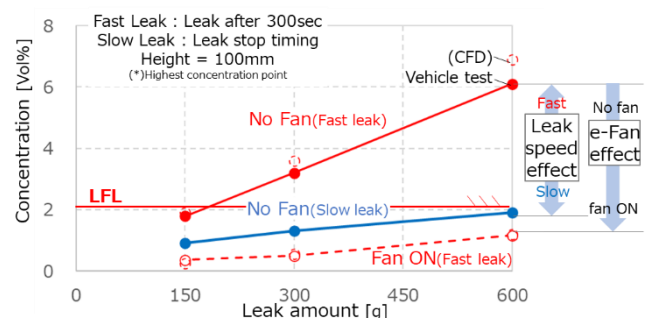
Fig.10 Leak amount vs. concentration (vehicle test)

漏洩量と速度を変化させた際の、300 秒時点の最高濃度をまとめた結果を図10に示す。速い速度の漏洩では、150g を越える漏洩量で LFL を超過する一方、車載ファン作動により、漏洩量 600g 以下で LFL を下回る結果となった。また遅い漏洩速度では漏洩量 600g まで LFL を超過しない。今回極端に厳しい条件として速い漏れ速度の評価を行ったが、車載ファンによる漏洩ガス拡散効果が実証された。

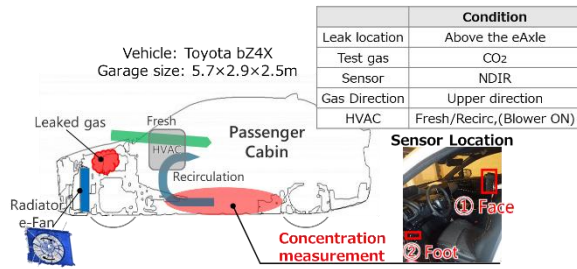
Fig.11 Vehicle test condition (cabin intake test)

車内でのエアコン作動を想定し、フロントコンパートメントで漏洩したガスが、HVAC の外気取り入れ口より車室内へ侵入する可能性について、実車評価を行った。図11に示すように、評価ガスとして CO<sub>2</sub> を活用し、車室内の運転席足元と顔付近にセンサーを設置、HVAC ブロー速度を最大として評価を行った。

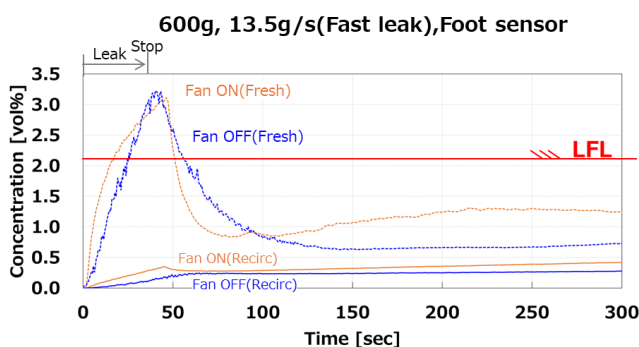
Fig.12 Comparison: fresh/recirc, fan ON/OFF (fast leak)

漏洩量 600g、速い漏洩における運転席足元付近の濃度分布を図 12 に示す。車載ファン作動の有無に関わらず、外気導入時はガス侵入により漏洩 15 秒以降に LFL を越え、その後濃度は低下する。一方、内気循環とすることで、車室内は低濃度が維持される。

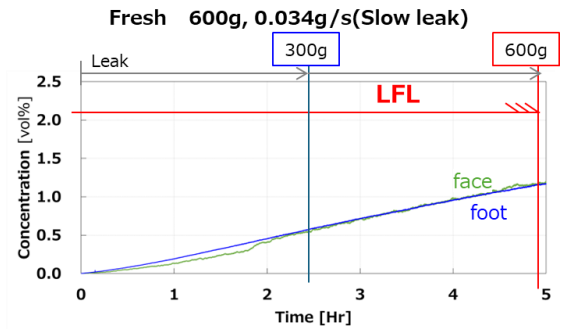
Fig.13 Comparison: fresh (slow leak, fan ON)

図 13 に漏洩量 600g、遅い漏れで車載ファン作動、外気導入条件での車室内濃度を示す。遅い漏れでは濃度は低く、600g 相当の漏洩でも、LFL 以下の濃度となった。

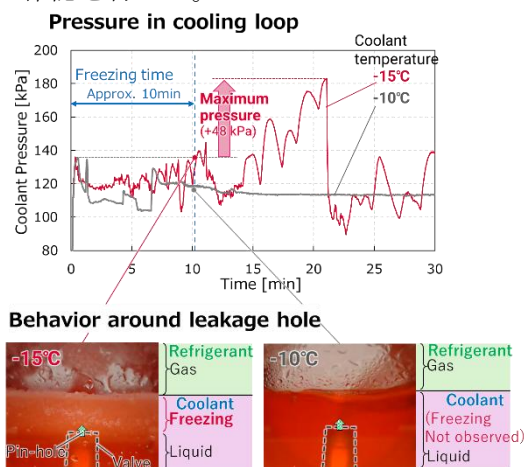
Fig. 21 Liquid leakage into the cooling loop (steady state)

図 21 に示すように、水温 $-15^{\circ}\text{C}$ 定常条件では、液冷媒侵入から凍結開始までに約 10 分かかり、それ以降で圧力の上昇がみられた。なお、比較として水温 $-10^{\circ}\text{C}$ では凍結が生じないことから、10 分以内に  $\Delta T=+5^{\circ}\text{C}$  の昇温が暖機過渡条件で生じるか確認を行った。

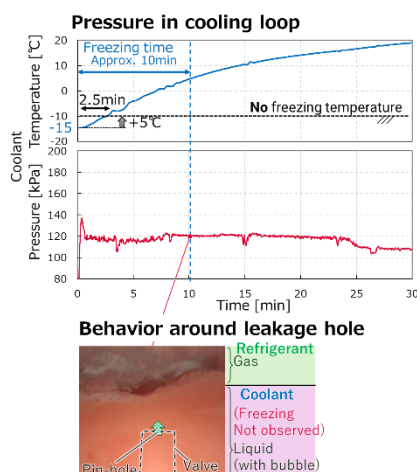
Fig. 22 Liquid leakage into the cooling loop (warm up)

一般的な使用状況を想定し、定常条件で凍結が発生した初期水温 $-15^{\circ}\text{C}$ にて、暖機過渡条件の評価を行った。図 22 に示すように、暖機開始後 2 分半以内に  $\Delta T=+5^{\circ}\text{C}$  の温度上昇に達し、凍結開始の基準とした 10 分よりも早く、圧力の異常な上昇も見られなかった。実際の暖機過渡状態においては、凍結によるリリーフバルブ固着、冷却回路の異常圧力や損傷のリスクが低いことが分かった。
